**Flood Control Project Maintenance
Levee Inspections**

Fall 2014 Levee Maintenance Deficiency Summary Report

Tehama County Flood Control and Water Conservation District

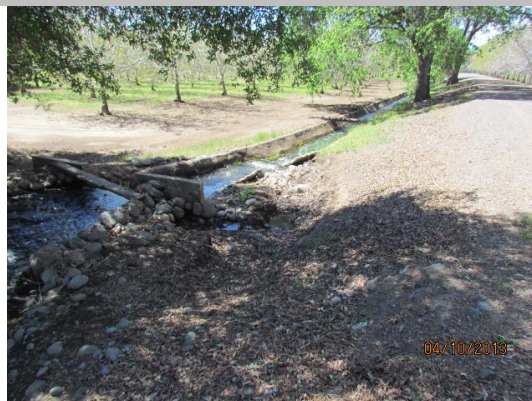
Photo 1 of 1 : FA_2014_NA0019_78_17_20141013_00009.jpg

View of the erosion along the landside slope.

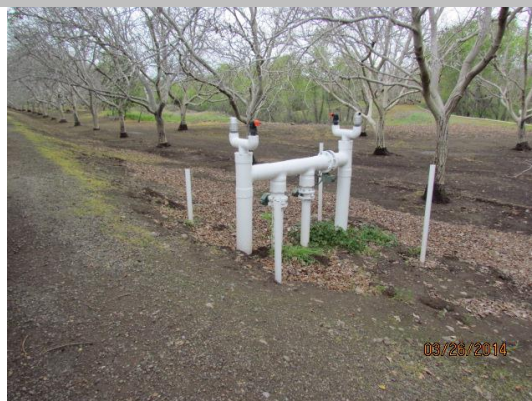
Photo 1 of 1 : FA_2014_NA0019_78_275_20141013_00014.jpg

LM Start	0.03	Rating **	U	Issue No.	275
LM End	0.03	Issue Type +	En	Location *	WS
Category	Earthen Levee			GPS Latitude/Longitude	
				Start	End
Item	Encroachments			39.973128 °	39.973128 °
				-121.980734 °	-121.980734 °
DWR ID	DWR_NA0019_01_s_2014_275				
Action/Comments					
Pipe

View of the irrigation pipe along the waterside slope.

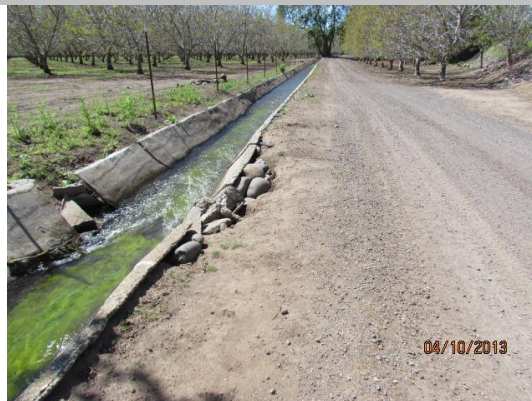
Photo 1 of 1 : FA_2014_NA0019_78_18_20141013_00010.jpg

View of the erosion along the landside slope.

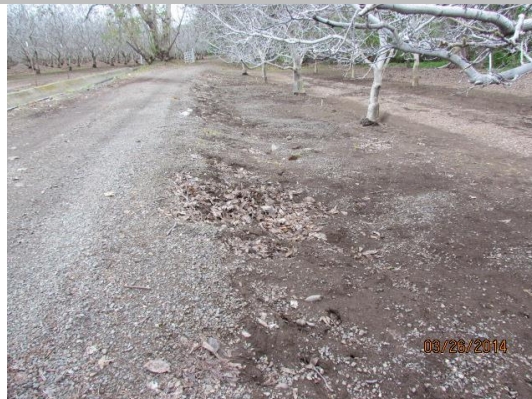
Photo 1 of 1 : FA_2014_NA0019_78_276_20141013_00015.jpg

LM Start	0.46	Rating **	M	Issue No.	276
LM End	0.46	Issue Type +	Ma	Location *	WS
Category	Earthen Levee			GPS Latitude/Longitude	
				Start	End
Item	Slope Stability			39.972377 °	39.972377 °
				-121.988559 °	-121.988559 °
DWR ID	DWR_NA0019_01_s_2014_276				
Action/Comments					
Repair slope instability.

View of the erosion along the waterside slope.

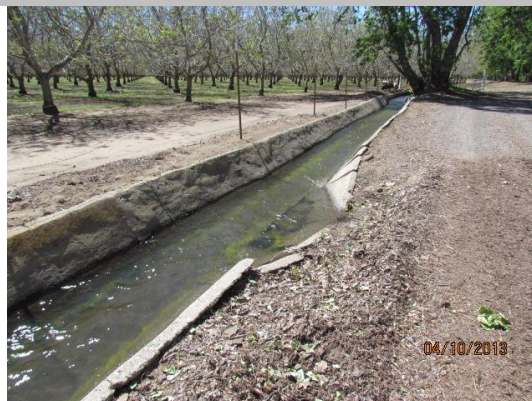
Photo 1 of 1 : FA_2014_NA0019_78_19_20141013_00011.jpg

View of the erosion along the landside slope.

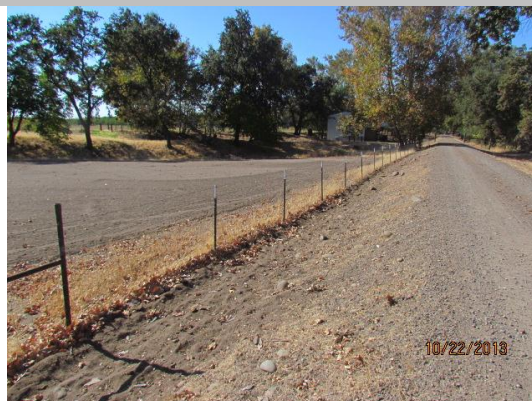
Photo 1 of 1 : FA_2014_NA0019_78_21_20141013_00013.jpg

LM Start	1.53	Rating **	M	Issue No.	21
LM End	1.53	Issue Type +	Ma	Location *	LS
Category	Earthen Levee			GPS Latitude/Longitude	
				Start	End
Item	Animal Control			39.969419 °	39.969419 °
				-122.007850 °	-122.007850 °
DWR ID	DWR_NA0019_01_f_2013_21				
Action/Comments					
Repair the levee slope damaged by livestock and prevent large animal access.

View of the erosion cause from livestock on both slope of the levee.

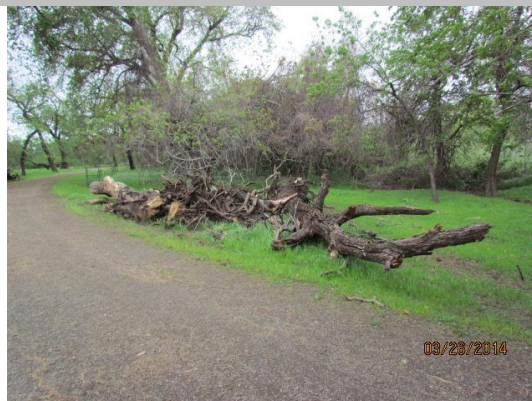
Photo 1 of 1 : FA_2014_NA0019_78_277_20141013_00016.jpg

View of the trees limbs along the waterside toe.

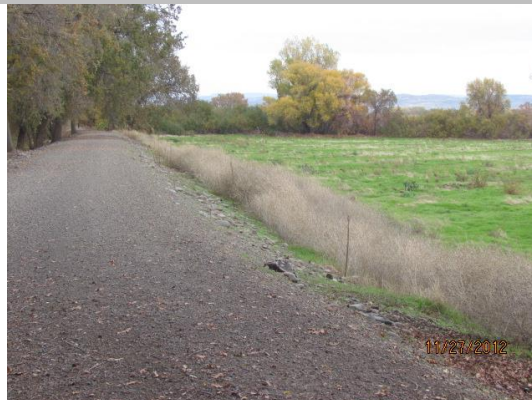
Photo 1 of 1 : FA_2014_NA0019_78_3_20141013_00002.jpg

LM Start	2.31	Rating **	M	Issue No.	3
LM End	3.04	Issue Type +	Ma	Location *	LS
Category	Earthen Levee			GPS Latitude/Longitude	
				Start	End
Item	Vegetation			39.967015 °	°
				-122.020781 °	°
DWR ID	DWR_NA0019_01_f_2012_3				
Action/Comments					
Remove the wild growth other than native grasses from the levee slopes.

View of the vegetation along the landside slope.

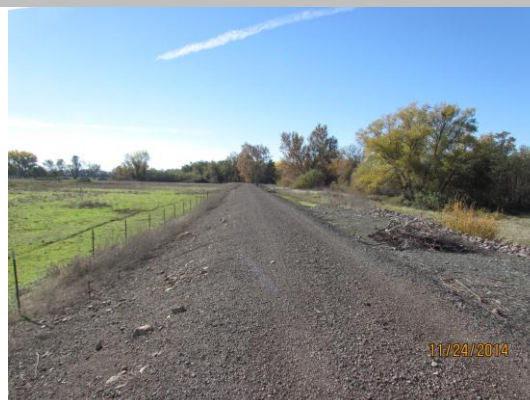
Photo 1 of 1 : FA_2014_NA0019_78_37_20141126_00026.jpg

View of the controlled vegetation on both slopes.

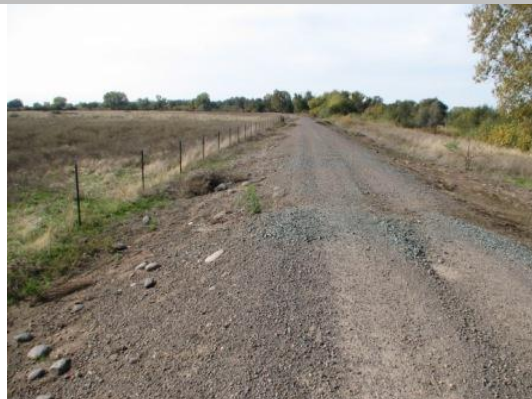
Photo 1 of 1 : FA_2014_NA0019_78_8_20141013_00003.jpg

LM Start	2.72	Rating **	M	Issue No.	8
LM End	2.76	Issue Type +	Ma	Location *	CR
Category	Earthen Levee			GPS Latitude/Longitude	
				Start	End
Item	Slope Stability			39.965434 °	39.965180 °
				-122.027776 °	-122.028331 °
DWR ID	DWR_NA0019_01_s_2012_8				
Action/Comments					
Repair the levee slope damaged by foot traffic and prevent access where possible.

Erosion on crown and both slopes.

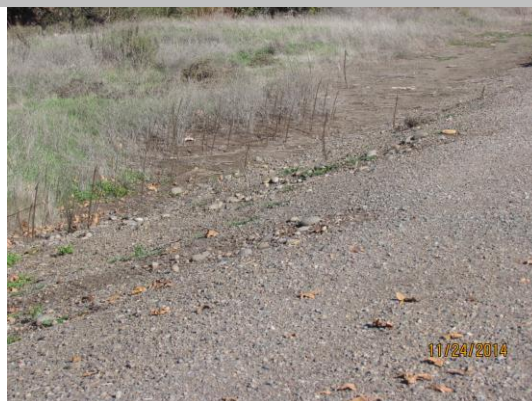
Photo 1 of 1 : FA_2014_NA0019_78_38_20141126_00027.jpg

LM Start	2.88	Rating **	M	Issue No.	38
LM End	2.88	Issue Type +	Ma	Location *	LS
Category	Earthen Levee			GPS Latitude/Longitude	
				Start	End
Item	Slope Stability			39.963928 °	39.963928 °
				-122.030120 °	-122.030120 °
DWR ID	DWR_NA0019_01_f_2014_38				
Action/Comments					
Repair slope instability.

View of erosion from the cattle on both slopes.

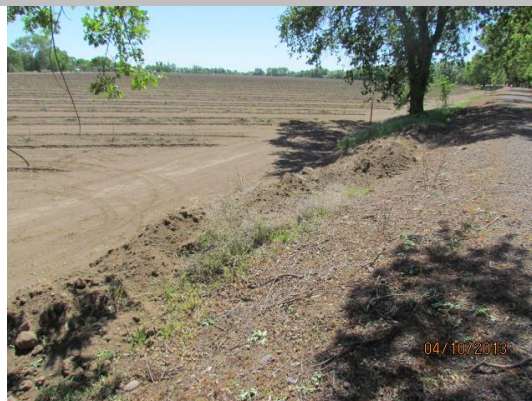
Photo 1 of 1 : FA_2014_NA0019_78_20_20141013_00012.jpg

LM Start	2.90	Rating **	M	Issue No.	20
LM End	2.90	Issue Type +	Ma	Location *	LS
Category	Earthen Levee			GPS Latitude/Longitude	
				Start	End
Item	Slope Stability			39.963709 °	39.963709 °
				-122.030384 °	-122.030384 °
DWR ID	DWR_NA0019_01_s_2013_20				
Action/Comments					
Repair slope instability.

View of the erosion along the landside slope.

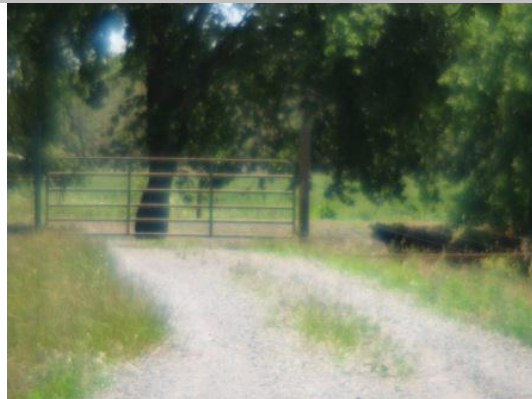
Photo 1 of 1 : FA_2014_NA0019_78_9_20141013_00004.jpg

View of the non-permitted gate on the crown of the levee.

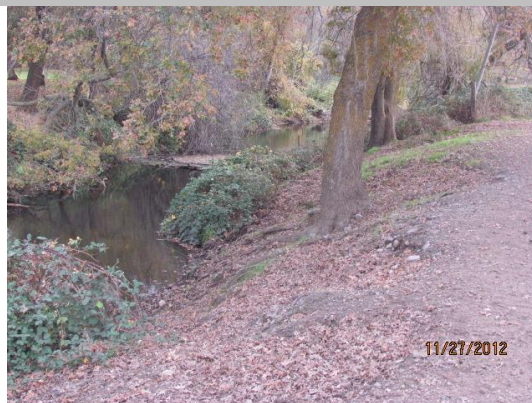
Photo 1 of 1 : FA_2014_NA0019_78_15_20141013_00007.jpg

View of the erosion caused by livestock along the landside slope.

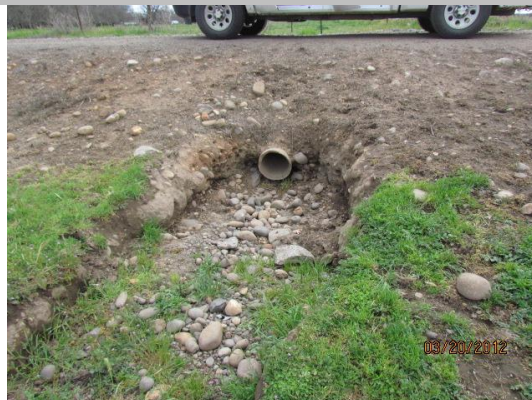
Photo 1 of 1 : FA_2014_NA0019_78_11_20141013_00006.jpg

No flap gate on 18 inch pipe going to the levee.

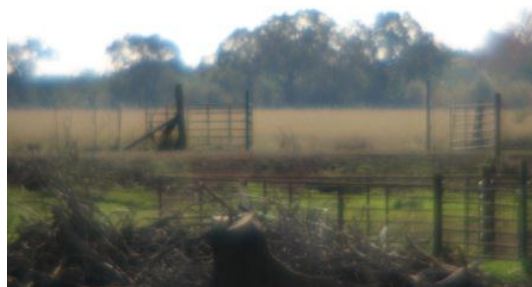
Photo 1 of 1 : FA_2014_NA0019_78_10_20141013_00005.jpg

View of the non-permitted gate on the crown roadway.

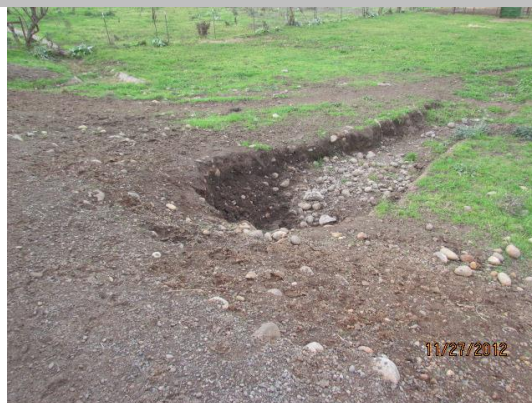
Photo 1 of 1 : FA_2014_NA0019_78_16_20141013_00008.jpg

LM Start	3.74	Rating **	M	Issue No.	16
LM End	3.74	Issue Type +	En	Location *	LS
Category	Earthen Levee			GPS Latitude/Longitude	
				Start	End
Item	Encroachments			39.944456 °	39.944456 °
				-122.053932 °	-122.053932 °
DWR ID	DWR_NA0019_01_f_2012_16				
Action/Comments					
Ditch

View of the ditch along the waterside toe.

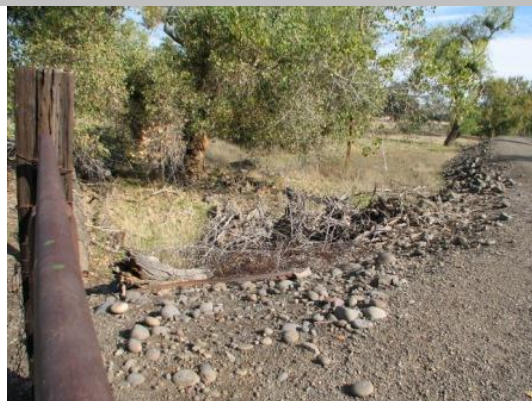
Photo 1 of 1 : FA_2014_NA0019_79_2_20141013_00001.jpg

View of debris & wire at toe of levee.

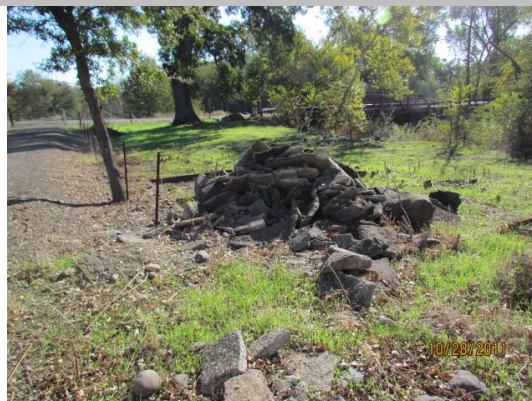
Photo 1 of 1 : FA_2014_NA0019_79_4_20141013_00003.jpg

View of the concrete pile along the W/S toe.

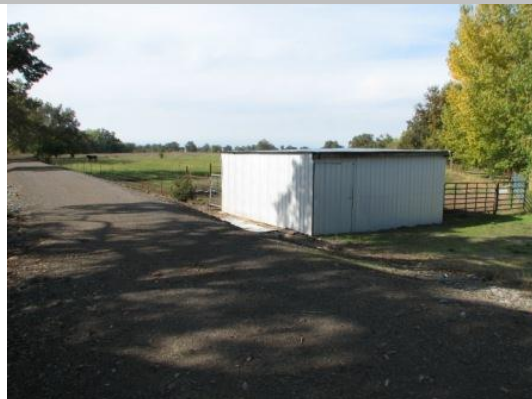
Photo 1 of 1 : FA_2014_NA0019_79_7_20141013_00005.jpg

View of building at toe of levee.

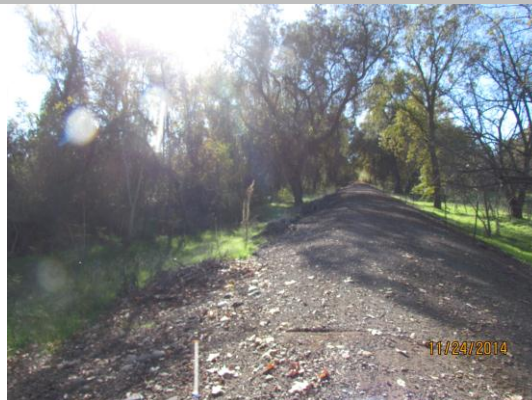
Photo 1 of 1 : FA_2014_NA0019_79_11_20141126_00007.jpg

View of controlled vegetation on both slopes.

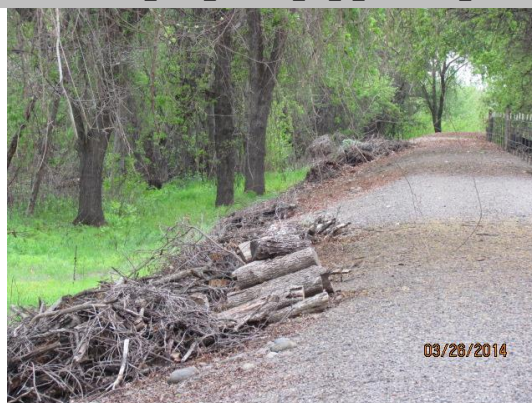
Photo 1 of 1 : FA_2014_NA0019_79_3_20141013_00002.jpg

View of the debris along the waterside slope.

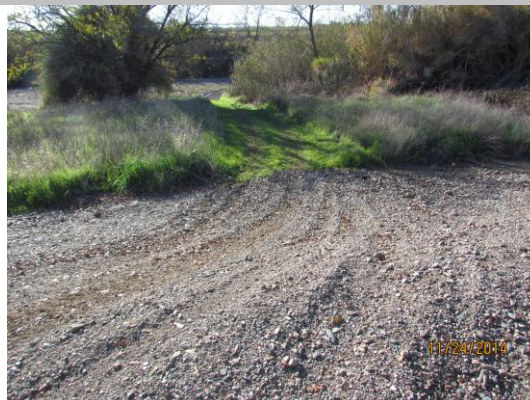
Photo 1 of 1 : FA_2014_NA0019_81_16_20141126_00015.jpg

LM Start	1.40	Rating **	M	Issue No.	16
LM End	1.40	Issue Type +	Ma	Location *	WS
Category	Earthen Levee			GPS Latitude/Longitude	
				Start	End
Item	Slope Stability			40.051493 °	40.051493 °
				-122.164935 °	-122.164935 °
DWR ID	DWR_NA0019_04_f_2014_16				
Action/Comments					
Repair the levee slope damaged by vehicle traffic and prevent access where possible.

View of the vehicle erosion along the waterside slope.

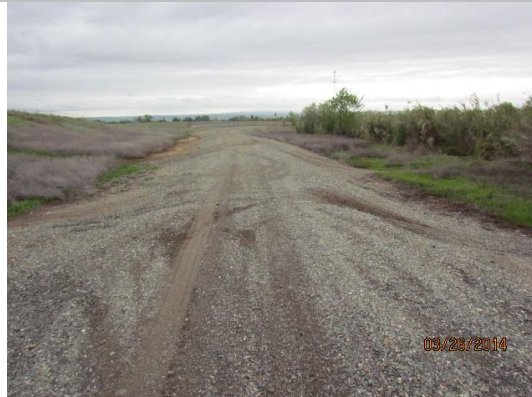
Photo 1 of 1 : FA_2014_NA0019_81_3_20141013_00003.jpg

View of the levee slope damaged by vehicle traffic.

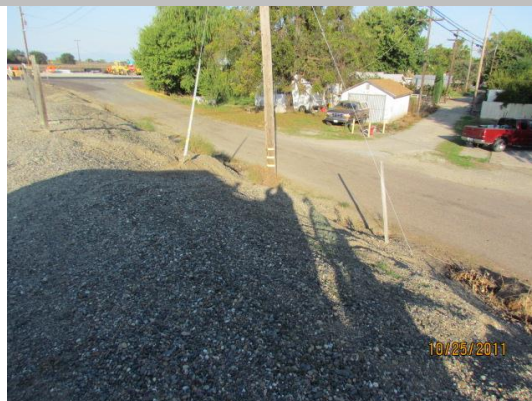
Photo 1 of 1 : FA_2014_NA0019_81_18_20141013_00009.jpg

View of the vehicle erosion along the L/S slope.

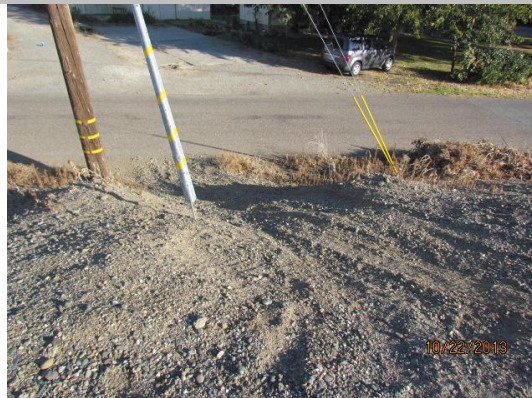
Photo 1 of 1 : FA_2014_NA0019_81_12_20141013_00008.jpg

View of the vehicle erosion along the landside slope.

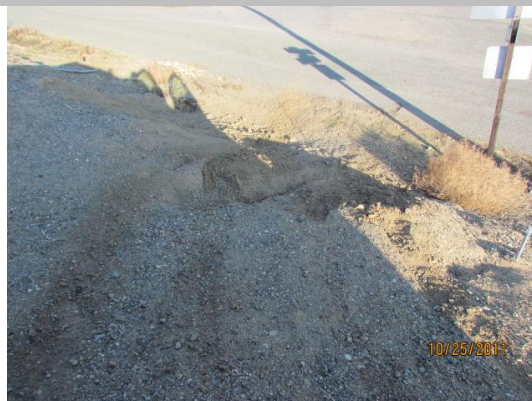
Photo 1 of 1 : FA_2014_NA0019_81_20_20141013_00010.jpg

View of the vehicle erosion along the L/S slope.

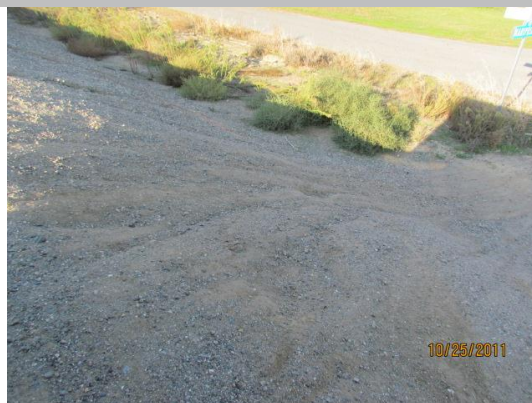
Photo 1 of 1 : FA_2014_NA0019_81_2_20141013_00002.jpg

LM Start	2.53	Rating **	M	Issue No.	2
LM End	2.53	Issue Type +	Ma	Location *	LS
Category	Earthen Levee			GPS Latitude/Longitude	
				Start	End
Item	Slope Stability			40.052872 °	40.052872 °
				-122.145495 °	-122.145495 °
DWR ID	DWR_NA0019_04_s _ 2012_2				
Action/Comments					
Repair the levee slope damaged by vehicle traffic and prevent access where possible.

View of the vehicle erosion along the L/S slope.

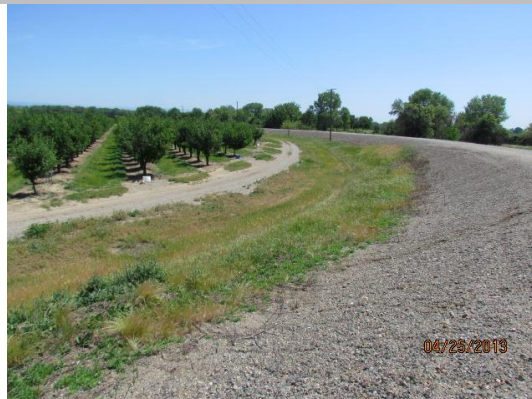
Photo 1 of 1 : FA_2014_NA0019_81_11_20141013_00007.jpg

View of the ditch along landside toe.

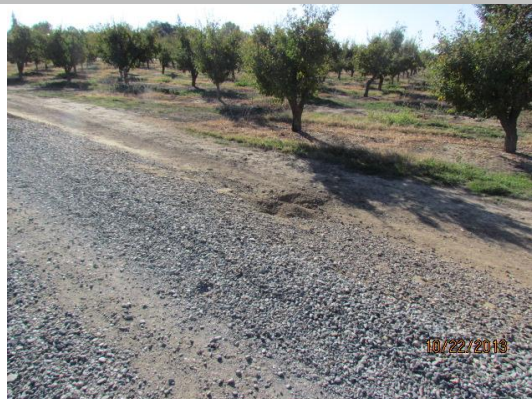
Photo 1 of 1 : FA_2014_NA0019_82_1_20141013_00001.jpg

View of the rodent holes along the landside slope.

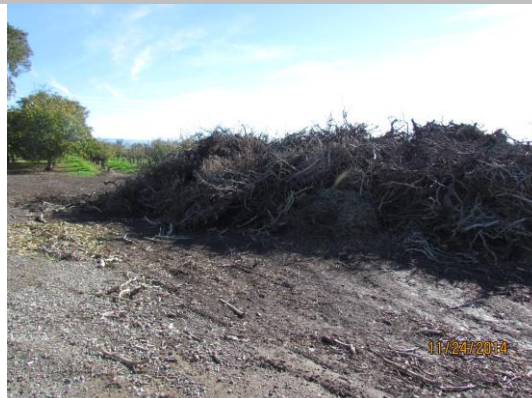
Photo 1 of 1 : FA_2014_NA0019_82_16_20141126_00010.jpg

View of the prunings along the landside slope.

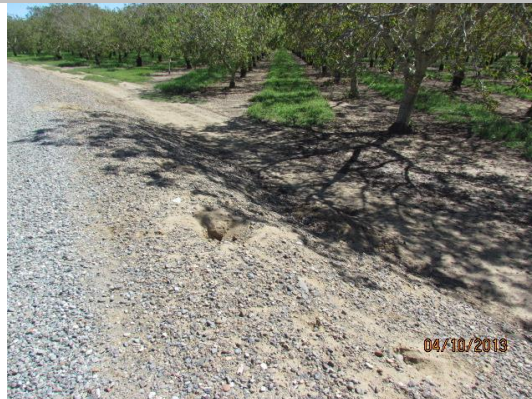
Photo 1 of 1 : FA_2014_NA0019_82_4_20141013_00003.jpg

View of the rodent holes along the levee slope.

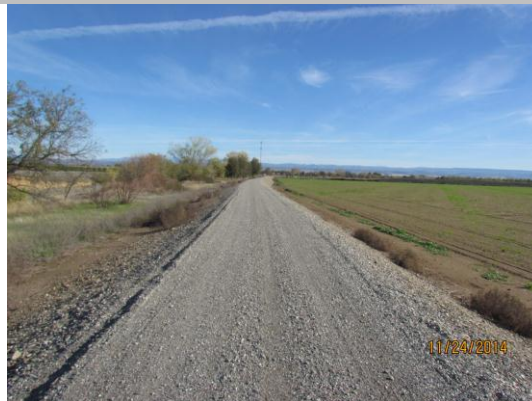
Photo 1 of 1 : FA_2014_NA0019_82_17_20141126_00011.jpg

LM Start	1.61	Rating **	A	Issue No.	17
LM End	1.61	Issue Type +	Ma	Location *	LS
Category	Earthen Levee			GPS Latitude/Longitude	
				Start	End
Item	Vegetation			40.050815 °	40.050815 °
				-122.164358 °	-122.164358 °
DWR ID	DWR_NA0019_05_f_2014_17				
Action/Comments					
Control annual grass and weeds on the levee slopes and easements.

View of the controlled vegetation on both slopes.

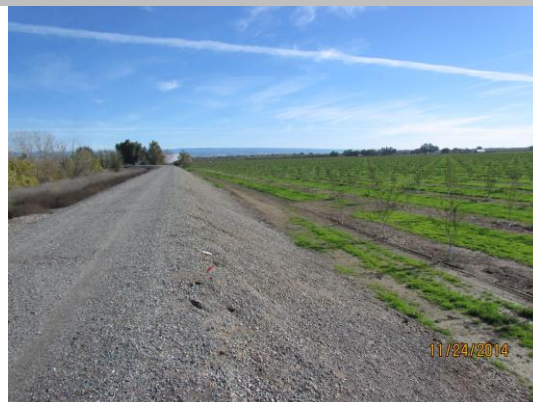
Photo 1 of 1 : FA_2014_NA0019_82_8_20141126_00013.jpg

View of the grouted rodent holes along the landside slope.

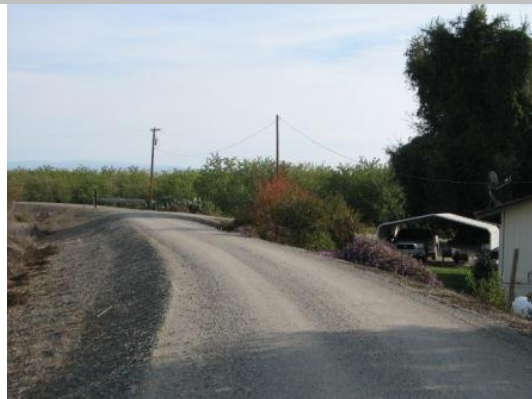
Photo 1 of 1 : FA_2014_NA0019_82_2_20141013_00002.jpg

View of the landscape along the slope.

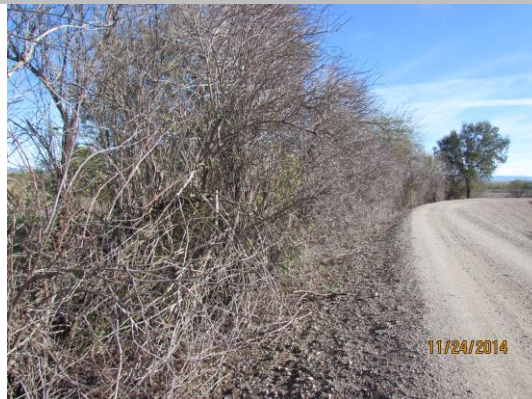
Photo 1 of 1 : FA_2014_NA0019_82_9_20141126_00014.jpg

View of the elderberries along the waterside slope and toe.

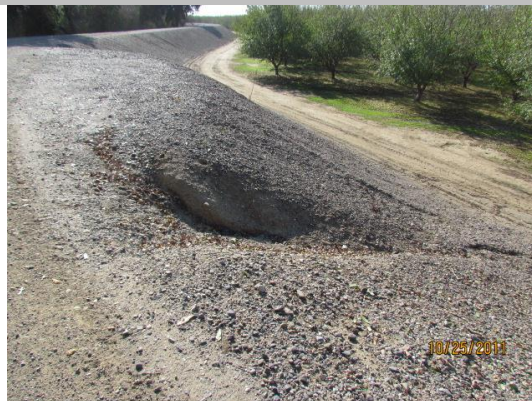
Photo 1 of 1 : FA_2014_NA0019_82_7_20141013_00005.jpg

View of the erosion along the L/S slope.
